Manhole Inspection Summary

Manhole # S06AA2025MH

Location Address: **3901 GIST AVE**

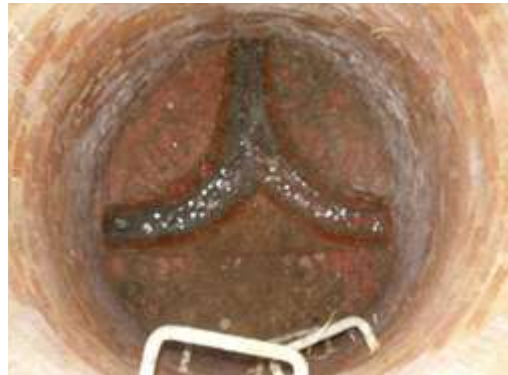
Top View

Barrel infiltration. Evidence of surcharge - Bench debris.

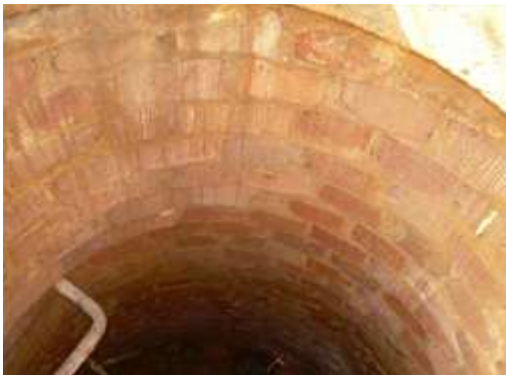
Defect

Frame leaks. Adjustment deterioration and infiltration.

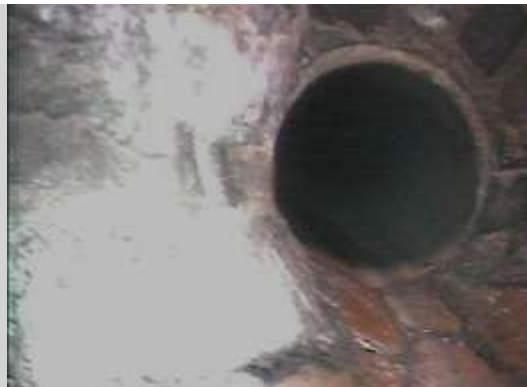
8 in. Circular Gravity Sewer Pipe In @ 3 O'Clock

Infiltration: **None** Pipe Seal Cond: **Unknown**

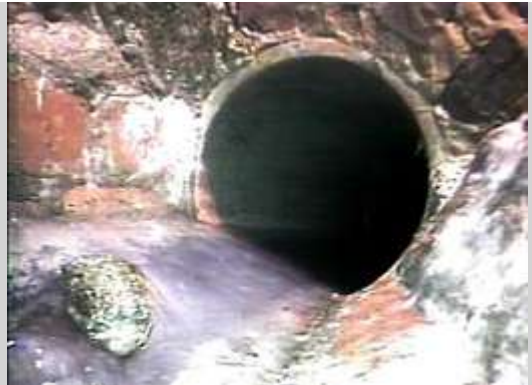
Pipe In @ 9 O'Clock

Infiltration: **None**
